Tracking Deformation Processes at the Legnica Glogow Copper District (Poland) by Satellite InSAR—II: Żelazny Most Tailings Dam

Citation: Mazzanti, P.; Antonielli, B.; Sciortino, A.; Scancellà, S.; Bozzano, F. Tracking Deformation Processes at the Legnica Glogow Copper District (Poland) by Satellite InSAR—II: Żelazny Most Tailings Dam. *Land* **2021**, *10*, 654. <https://doi.org/10.3390/land10060654>

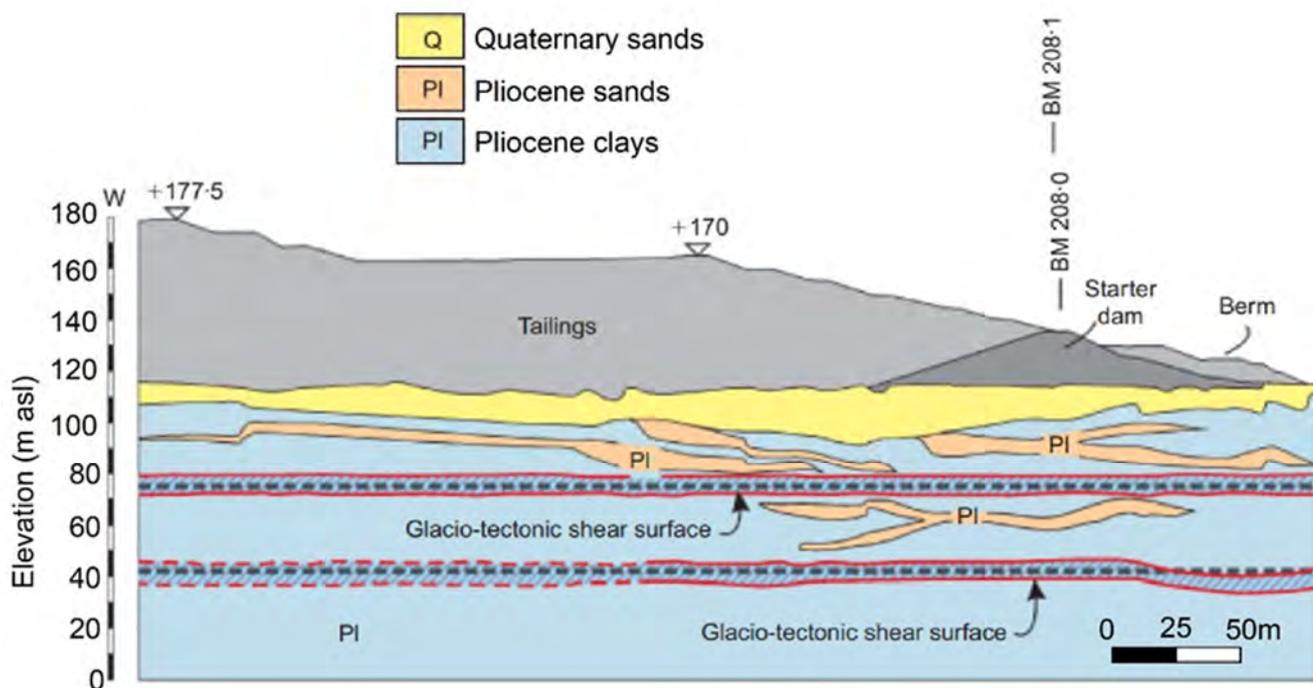
Figure 2. Section XVIIE of the Želazný Most Tailings dam (eastern part of the dam; modified form [1], reprinted with permission from [1]. 2014, ICE Publishing). Glacio-tectonic shear surfaces are represented in red.

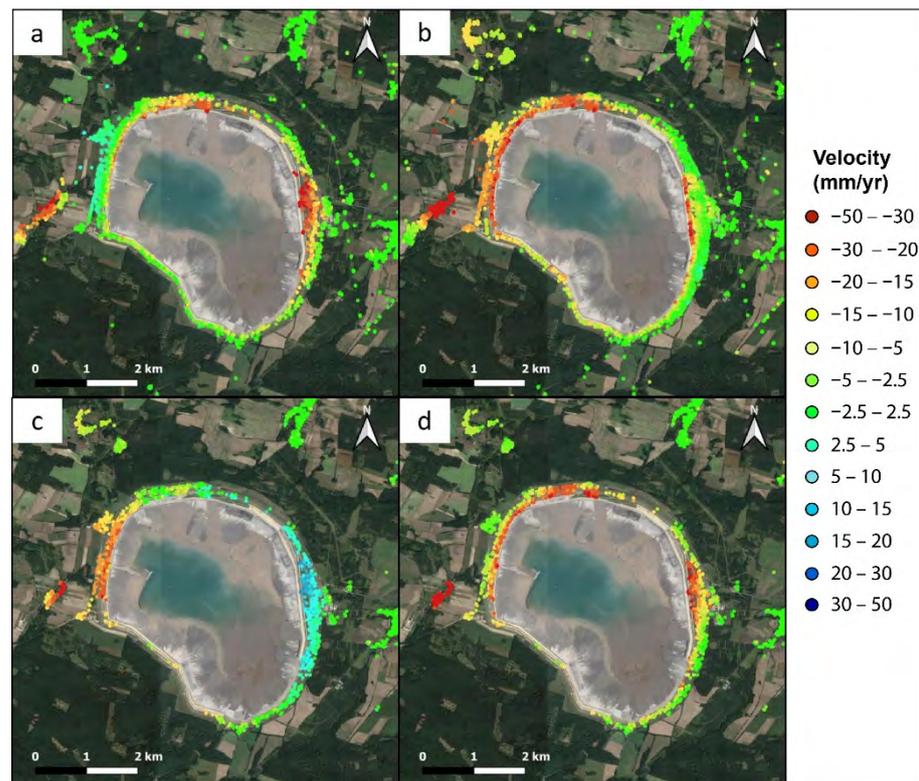
The A-DInSAR velocity maps of the Źelazny Most TSF, for the period October 2014–April 2019, are shown in Figure 4. The panels a and b show the LOS velocity, in ascending and descending orbital geometry respectively, while c and d the east-west and up-down velocity maps, respectively. For the LOS velocity maps, the used convention for the color bar is as follows: green PSs represent the velocity range between -2.5 and 2.5 mm/yr, which has been considered no deformation; PSs moving away from the satellite are in yellow, orange, and red, while PSs moving toward the satellite are from cyan to blue. For the east-west and up-down velocity maps, the green PSs represent no displacement; yellow to red PSs are moving westwards or downward, respectively, while cyan to blue PSs are moving eastward or upwards, respectively.

As regards the horizontal displacements (east-west direction in Figure 4c), it is worth noting that, along the eastern embankment of the dam, PSs are moving eastwards with velocity up to 30 mm/yr, while along the western embankment, PSs are moving westwards, with similar maximum rate of displacement (up to -30 mm/yr). Therefore, in these sectors of the dam, the embankment is deforming outwards, i.e., the velocity vectors are radial with respect to the center of the basin. Along the northern sector of the dam, instead, the east-west deformation rates are very small, with values ranging between 5 and -5 mm/yr. The horizontal rates in the north-south direction, as mentioned in the previous paragraph, cannot be properly measured by InSAR [49,50].

As regards the vertical displacements (Figure 4d), PSs moving downwards (subsidence) are in yellow to red colors, while there are no areas with PSs moving upwards (uplift). The velocity values measured along the vertical direction show that several parts of the dam ring are affected by subsidence or settlement (hereinafter considered as synonyms). The southern part of the dam shows lower subsidence (from -5 to -15 mm/yr), while in all other sectors of the dam, subsidence is more intense, especially in the innermost and higher rings. In the eastern sector, the subsidence rate is up to -30 mm/yr in the innermost part of the tailings dam ring, with peak values of -50 mm/yr in the central part of the eastern sector. Subsidence decreases up to values of -5 mm/yr towards the base of the dam structure, i.e., in the so-called starter dam. In the western sector of the tailings dam a similar pattern of deformation can be observed: in the innermost rings the subsidence is up to -30 mm/yr, while in the starter dam the settlements are in the order of -6 mm/yr. In the northern sector of the dam, the maximum velocity is about -35 mm/yr in the inner portion of the dam and decreases in the starter dam.

Figure 4. A-DInSAR velocity of displacement maps (mm/yr) of the Želazný Most tailings dam for the period October 2014–April 2019; (a,b) velocity in LOS ascending and descending orbital geometry respectively; green PSs are considered as stable; yellow-red PSs are moving away from the satellite; cyan-blue PSs are moving toward the satellite; (c) velocity in east-west direction; cyan-blue PSs are moving eastwards; yellow-red PSs are moving westwards; (d) velocity in up-down direction; yellow-red PSs are moving downward.

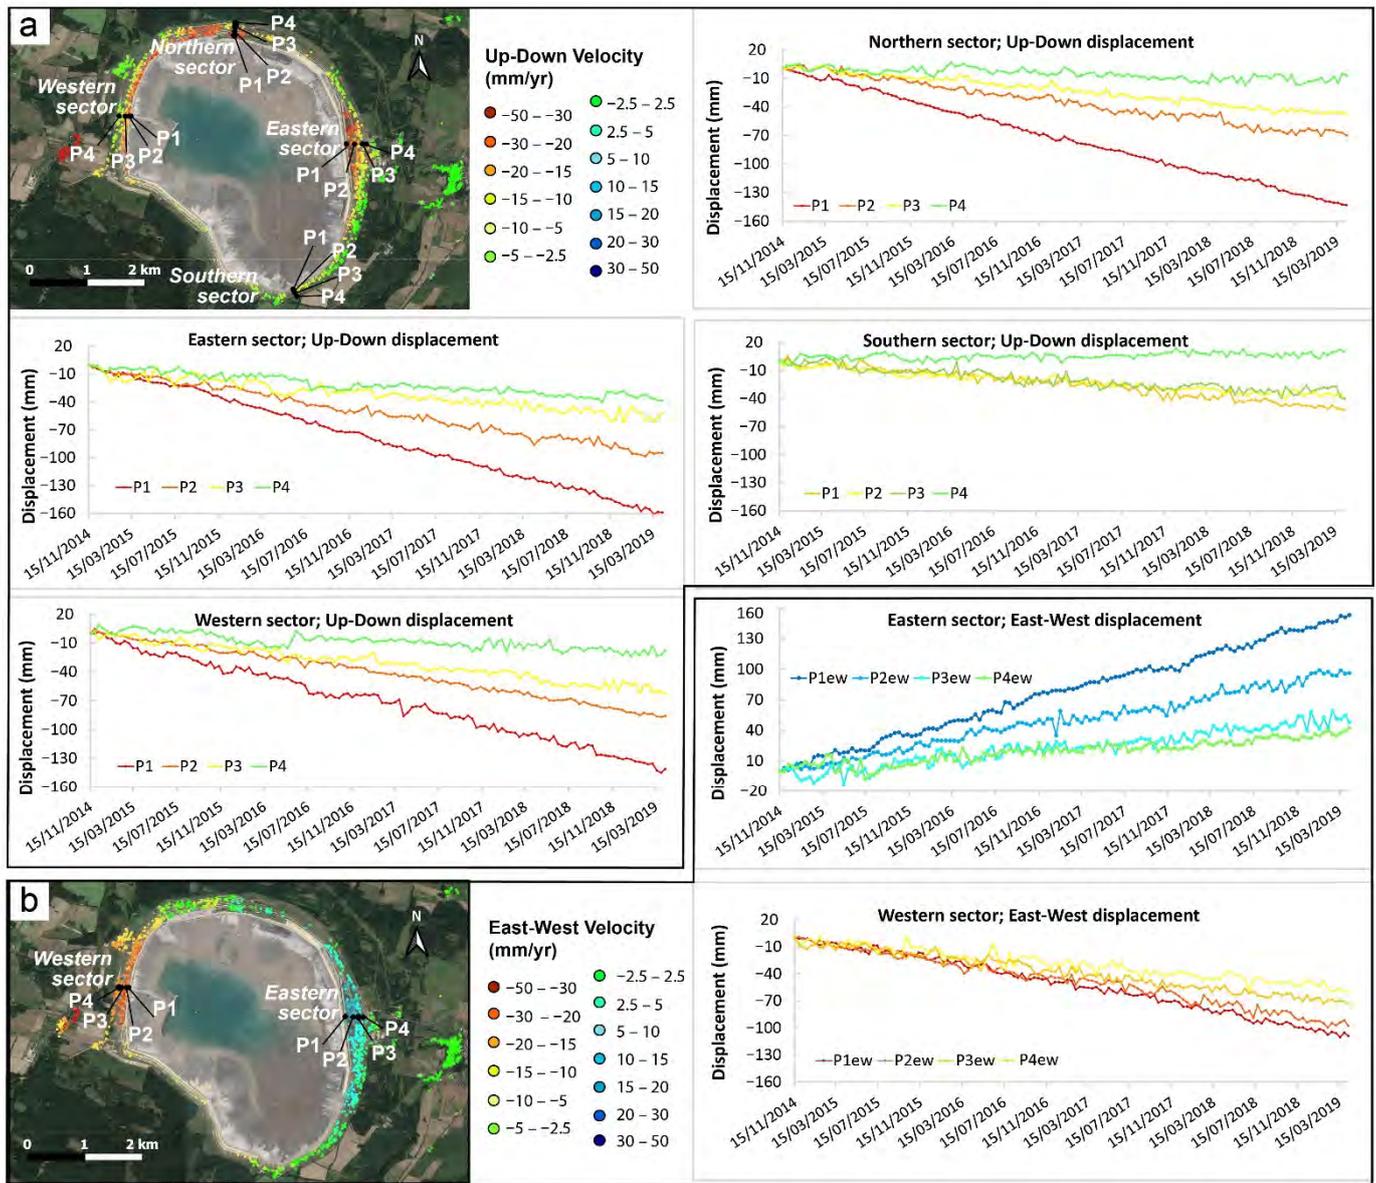
In order to analyze the trend of horizontal and vertical displacement over time, the time series of displacement has been computed for each measurement point. Some interesting examples are shown in Figure 5: for each sector of the dam, four time series selected at different highs of the dam body are represented (location of the selected points is also given in the map panels). For each dam sector, Points P1 are located near the beach and the ponds, in a higher position; points P2 and P3 are selected in the middle highs, and P4 are located on the starter dam. The time series of vertical displacements (Figure 5a) highlights that the points P1 show steep trends, as they are affected by intense deformation. The deformation pattern increases quite steadily over time (from October 2014 to April 2019), with a linear trend. The displacements become more and more moderate, going down in altitude at points P2, P3, and P4 (less steep time series).

Figure 5. Time series of displacement for the Želazny Most TSF; (a) time series of up-down displacements for the northern, southern, eastern and western sectors of the dam; downward displacements are in red; (b) time series of east-west displacements for the eastern and western sectors of the dam; eastward displacements are in blue, westward displacement are in red. The location of the PSs selected for processing the time series is also shown in the map panels.

As regards the time series of east-west displacements (Figure 5b), the eastward displacements are shown in blue, and westward displacements are in red. Also in this case, the trend of the time series shows larger cumulative displacements values for points located near the beach and the ponds (P1ew and P2ew) compared to the points at the foot of the dam (P3ew and P4ew). However, such difference in the horizontal deformation patterns is very weak in the western sector of the dam, where the displacement towards the west (or towards the outside), seems to take place as an en bloc movement.

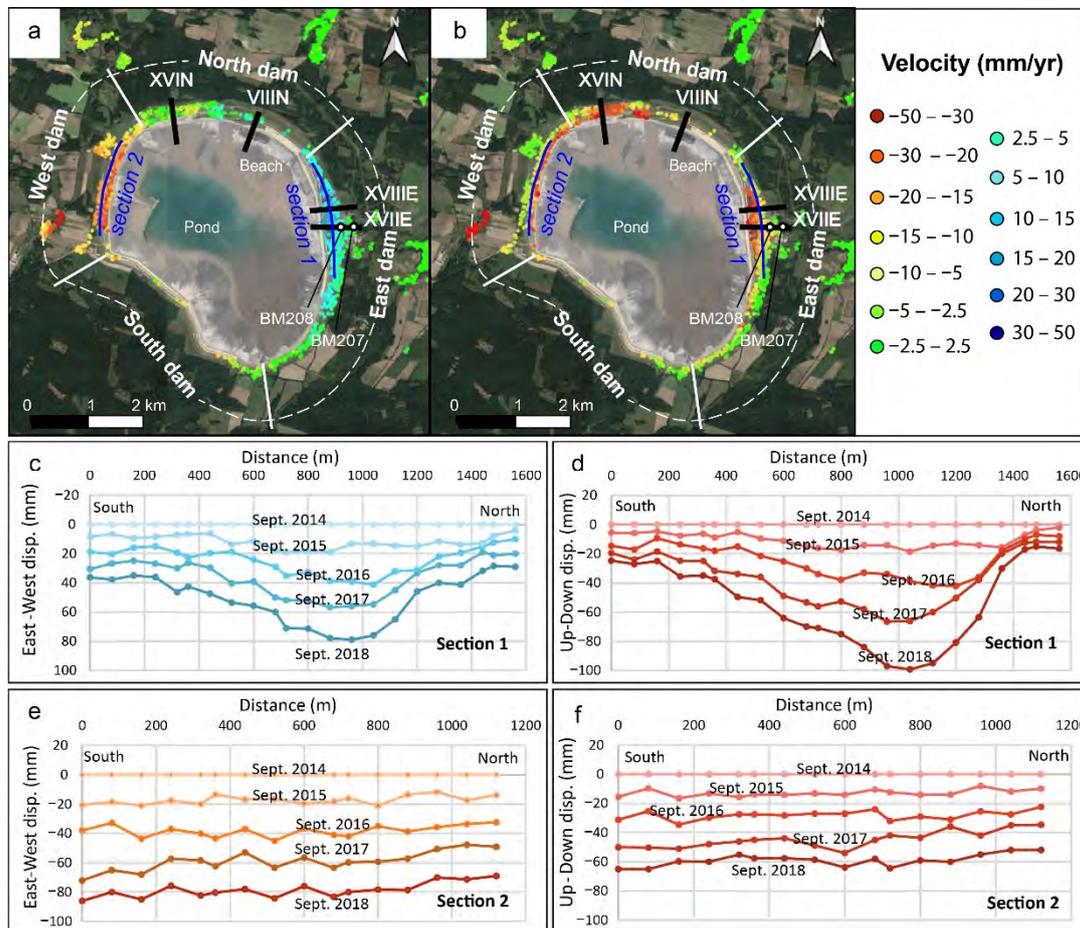
Figure 6. Longitudinal sections of cumulative displacement along the eastern dam (Section 1) and the western dam (Section 2); sections and dam sectors location are overlaid on (a) the east-west velocity map and (b) the up-down velocity map; (c) east-west displacement along the Section 1; (d) up-down displacement along the Section 1; (e) east-west displacement along the Section 2; (f) up-down displacement along the Section 2.

Section 1, which concerns the eastern dam, shows that the eastern perimeter of the dam does not deform uniformly, but the central zone of the section shows more intense displacement, both in the horizontal (Figure 6c) and vertical directions of movement (Figure 6d), with maximum cumulative displacement of 80 mm eastwards and 100 mm downward, in about four years. As discussed above, higher deformation values are expected at higher altitudes of the dam, and lower values are expected at the base of the dam.

Section 2, along the western dam, instead shows a uniform pattern of deformation both in the horizontal (Figure 6e) and vertical directions (Figure 6f), with maximum horizontal cumulative displacements similar with respect to the eastern sector (about 80 mm), but in the opposite direction (i.e., westwards), and the cumulative subsidence is around 60 mm in about four years.

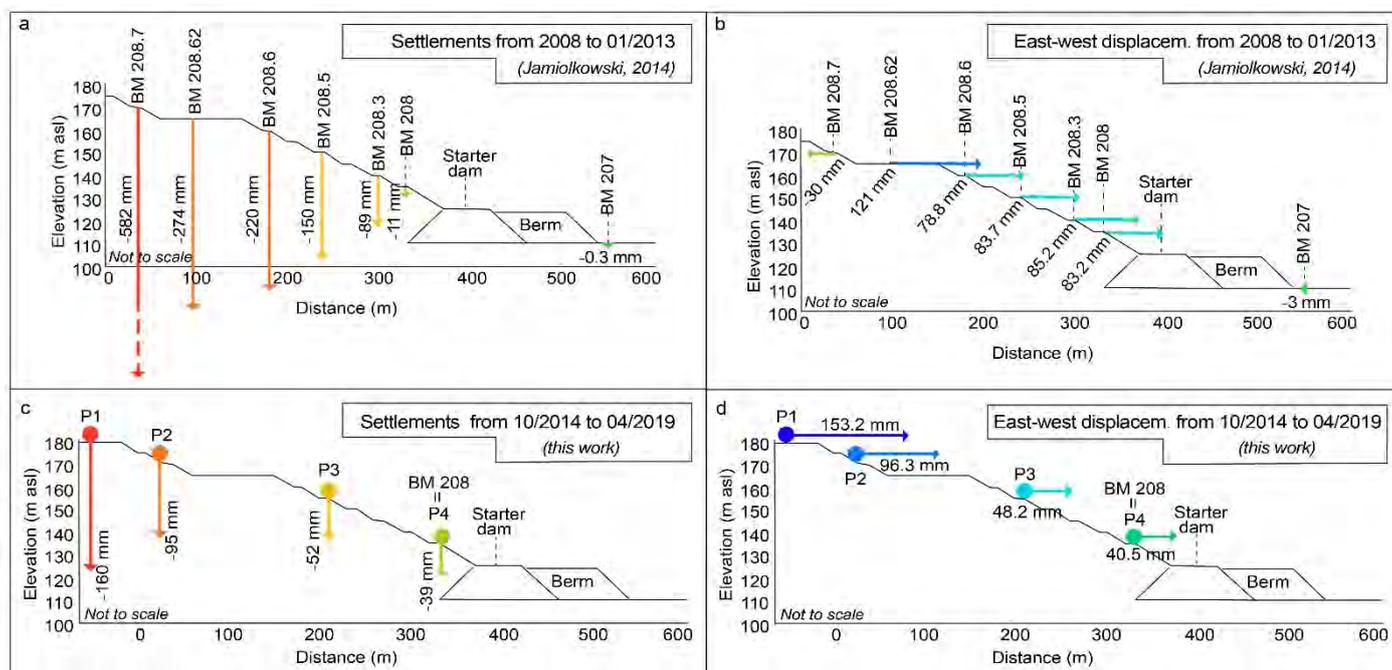
The Želazny Most dam structure is affected by a complex deformation pattern that involves both the vertical and horizontal directions. As regards the vertical displacements, the deformation corresponds to subsidence (or settlements) occurring on the dam ring with different intensity depending on the position and altitude along the dam body: higher in the

upper part and lower at the base of the dam ring. Such differential movement also concerns horizontal displacements for the eastern sector. This pattern of deformation is represented on a schematic cross section (cross-section XVIIE of Jamiolkowski [1] located in Figure 6a,b) in Figure 7, where both settlements and horizontal displacement are represented for two time intervals: from 2008 to 2013, with values deduced from Jamiolkowski [1] and from 2014 to April 2019, with data measured by A-DInSAR technique. The original values of cumulated displacements provided by Jamiolkowski [1] covered different time frames for each benchmark represented on Figure 7 a,b, as each benchmark was monitored since different dates: for example, the benchmark BM-208 located at the starter dam (location in Figure 6a,b), was monitored from 1981 until 2013, while BM-208.7, on top of the dam, was added later and was monitored from 2007 until 2013. To make these displacement values comparable to each other and roughly comparable also with those retrieved by the A-DInSAR four-year analysis, the average annual velocity for each benchmark has been calculated, and the related displacement value has been obtained for a time interval of four years.

Figure 7. Schematic cross-section XVIIE (location in Figure 6a,b) on the eastern dam; vectors represent the cumulative settlement (mm) at different heights of the dam body; (a,b) settlements and east-west displacements, respectively, from 2008 to January 2013 at 7 benchmarks (deduced from [1]); (c,d) settlements and east-west displacements respectively, from October 2014 to April 2019, measured by A-DInSAR, at points P1, P2, P3, and P4 (located in Figure 5).

Figure 7c and d show the superficial deformation achieved by A-DInSAR technique from October 2014 to April 2019 at the points P1, P2, P3, and P4, located in Figure 5.

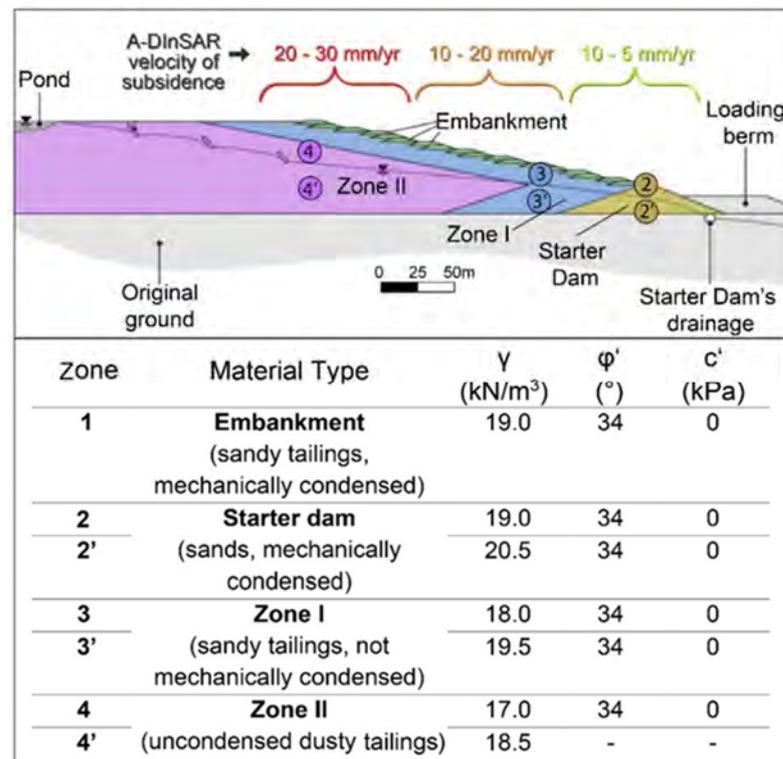
Figure 8. Scheme of tailings zoning in the site's embankment and selected geotechnical parameters of the soil form [30]; 2', 3' and 4' are for fully saturated material; γ : unit weight; ϕ' : internal friction angle; c' : effective cohesion; AD-InSAR subsidence velocities measured in this work are also reported above the profile.

According to Stefanek et al. [30], the material type that forms the starter dam is sand mechanically condensed (2 and 2' in Figure 8). In this basal part of the dam ring, the subsidence rate can range from 5 to 10 mm/yr. Zone I consists of sandy tailings, not mechanically condensed (3 and 3' in Figure 8) and Zone II, which is the most inner part of the dam structure (4 and 4' in Figure 8) is made of uncondensed dusty tailings. The parts of the embankment affected by more intense subsidence (20–30 mm/yr) are founded on greater thicknesses of sandy tailings not mechanically condensed or on uncondensed dusty tailings (note the thickness of the Zone II in Figure 8). Therefore, the more pronounced subsidence rates in the highest sectors of the dam could be linked both to the most recent age of construction and to the larger thickness of compressible materials in the inner part of the dam body.

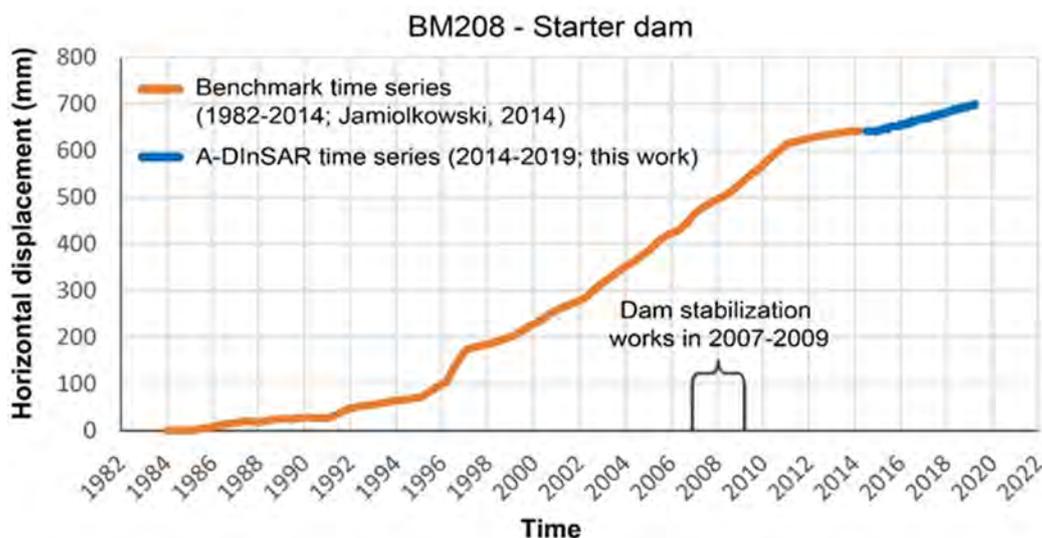
Figure 9. Time series of horizontal surface displacements of benchmarks BM-208; orange line: benchmark time series from [1]; blue line: A-DInSAR time series.

It is worth mentioning that the time series of the displacement of BM208 represents the behavior of the base of the dam structure (starter dam), while at higher altitudes of the dam, the intensity of horizontal displacements is considerably greater, as stated above (Figure 7b,d). As discussed in previous works, the geodetic and the inclinometer data show that the starter dam and the foundation soil above the shallower shear plane in clays

(45 m asl) move as a single, rigid body [1]. This behavior changes at higher elevations within the dam, where there is a more complex deformation mechanism.

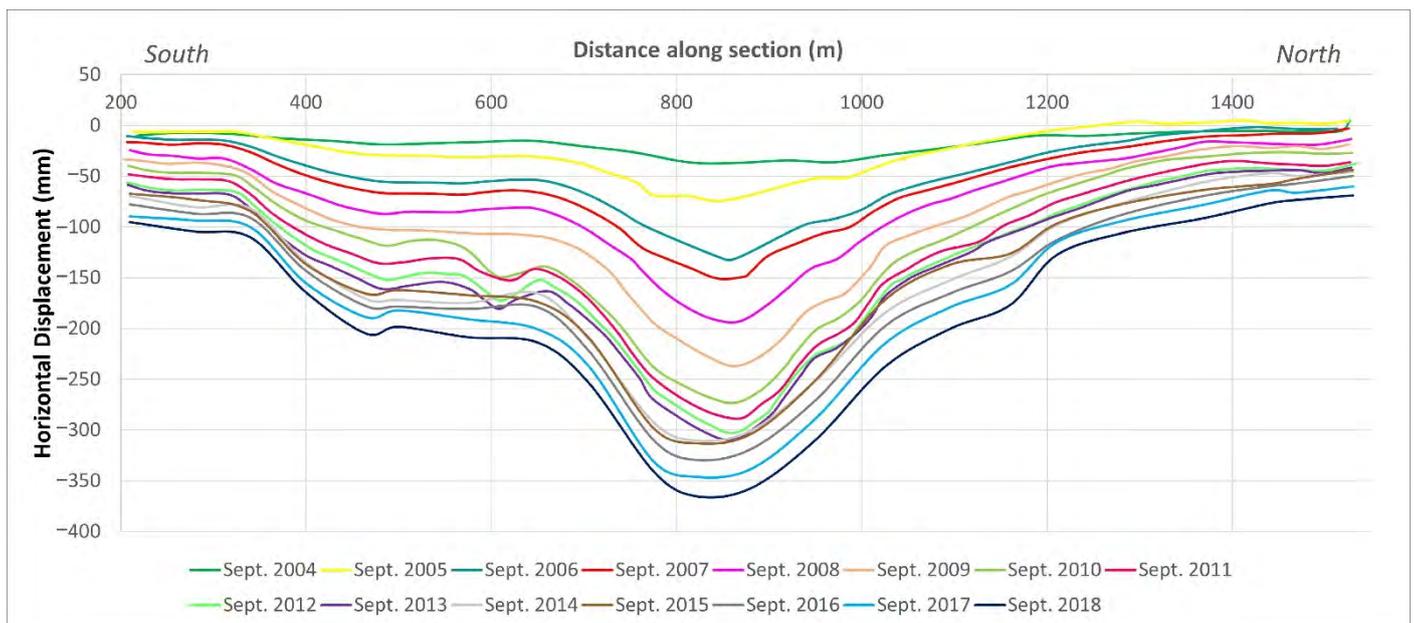
The longitudinal section along the eastern dam (Section 1 in Figure 6a,b) shows how cumulative displacement is distributed along the eastern perimeter and allows for the analysis of the spatial deformation pattern of the east side of the dam. Each curve of the graph shows the cumulative deformation that affected the dam up to September of each year. This timing was chosen in order to compare and combine this graph with the same longitudinal section of Jamiolkowski [1], which represents a plan view of horizontal cumulated displacements from 2004 to 2013. The latter has been extended with the measurements obtained by A-DInSAR for the years 2014–2018, along the longitudinal section at medium height of the dam (Figure 10). Despite some uncertainties about the exact location of the section of Jamiolkowski, the curves show a very similar trend: greater displacements occur in the central part of the eastern dam, and the rates of eastward displacement (that can be deduced by the distance between the curves) are similar. Two remarks can be made about the above mentioned discussion: the first one is that in the eastern sector of the TSF, the dam does not behave like a rigid body and shows areas of greater weakness in the central part; the second remark is that, although the horizontal deformation seems to have had a slowdown from 2010 to 2013, it continued in 2014 to 2018 with recovered intensity, up to almost 370 mm of displacement. It is possible that stabilization and prevention works performed to reduce the lateral sliding of the dam have not been effective.

Figure 10. Longitudinal section of cumulative horizontal displacement along the eastern dam (Section 1, location in Figure 6a); curves from 2004 to 2013 are from [1]; curves from 2014 to 2018 are from AD-InSAR measurements.
