Article

The Contribution of Terrestrial Laser Scanning to the Analysis of Cliff Slope Stability in Sugano (Central Italy)

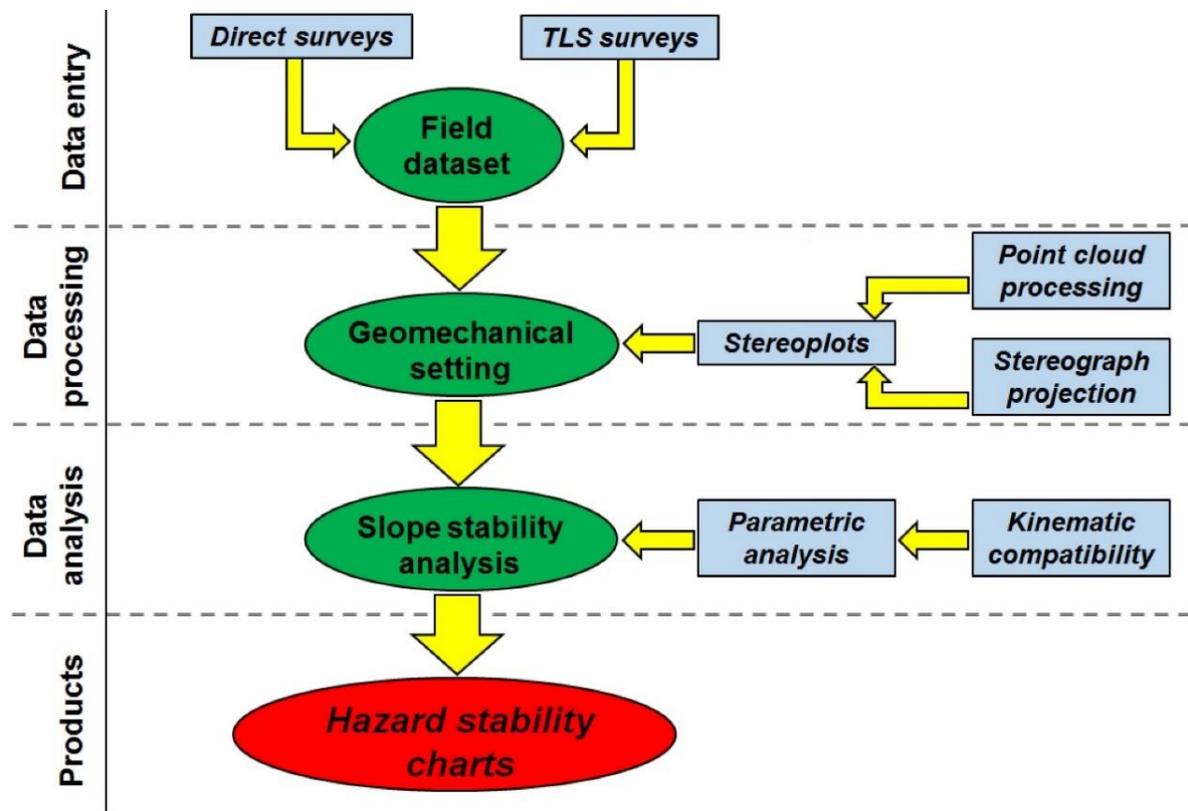
Figure 1. Flow chart of the applied methodology, which is based on data from direct and Terrestrial Laser Scanning (TLS) surveys.

This paper describes a combined methodology that exploits the potential of TLS in the framework of a slope stability analysis of a rocky cliff. Specifically, we present the results of a detailed investigation carried out on a cliff frequently affected by instability processes located below the village of Sugano (close to Orvieto, Central Italy). Geomechanical characterization of the cliff was carried out starting from 3D high-resolution point clouds collected by TLS surveys [15,16] with the aim of assessing the overall predisposition to failure of the cliff by accounting for different triggering scenarios. Specifically, the adopted procedure can be summarized in four levels of activity (Figure 1):

1. data acquisition, including direct geomechanical scan lines on site and TLS surveys;
2. data processing consisting in point cloud filtering and triangulation, stereograph projection and geomechanical setting restitution;
3. data analysis, including a kinematic compatibility analysis performed using the Markland tests [17] for rock toppling and a sensitivity analysis for rock toppling in relation to different potential triggering factors; and
4. delivery of final products consisting in hazard stability charts.

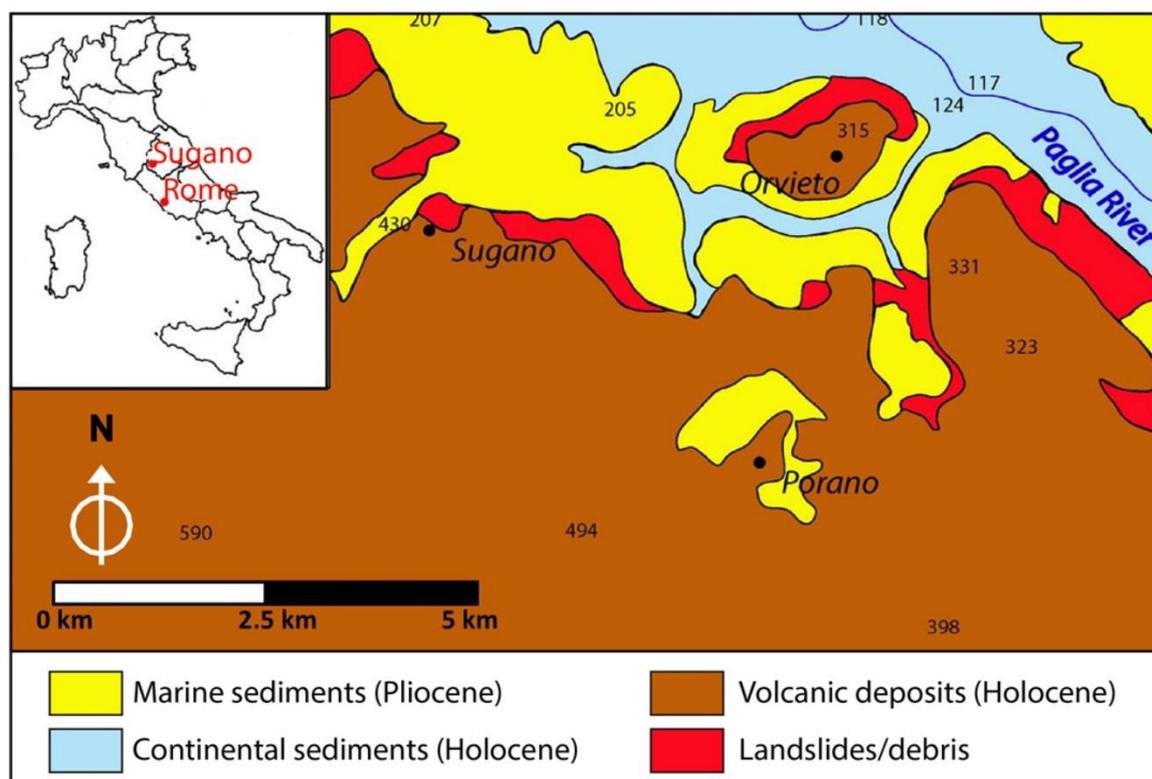
Figure 2. Geological sketch of the study area. Elevation (in m a.s.l.) is also reported for specific points.

Sugano is a small hamlet of Orvieto Municipality in the province of Terni (Umbria, Central Italy), about 100 km north of Rome. The village is located in the geologic domain of the Alfina plateau, a broad quaternary volcanic plateau outcropping in the northern part of the Lazio Region [18]. The outcropping rocks are namely Pliocene sedimentary rocks, volcanic deposits and recent alluvial sediments (Figure 2).

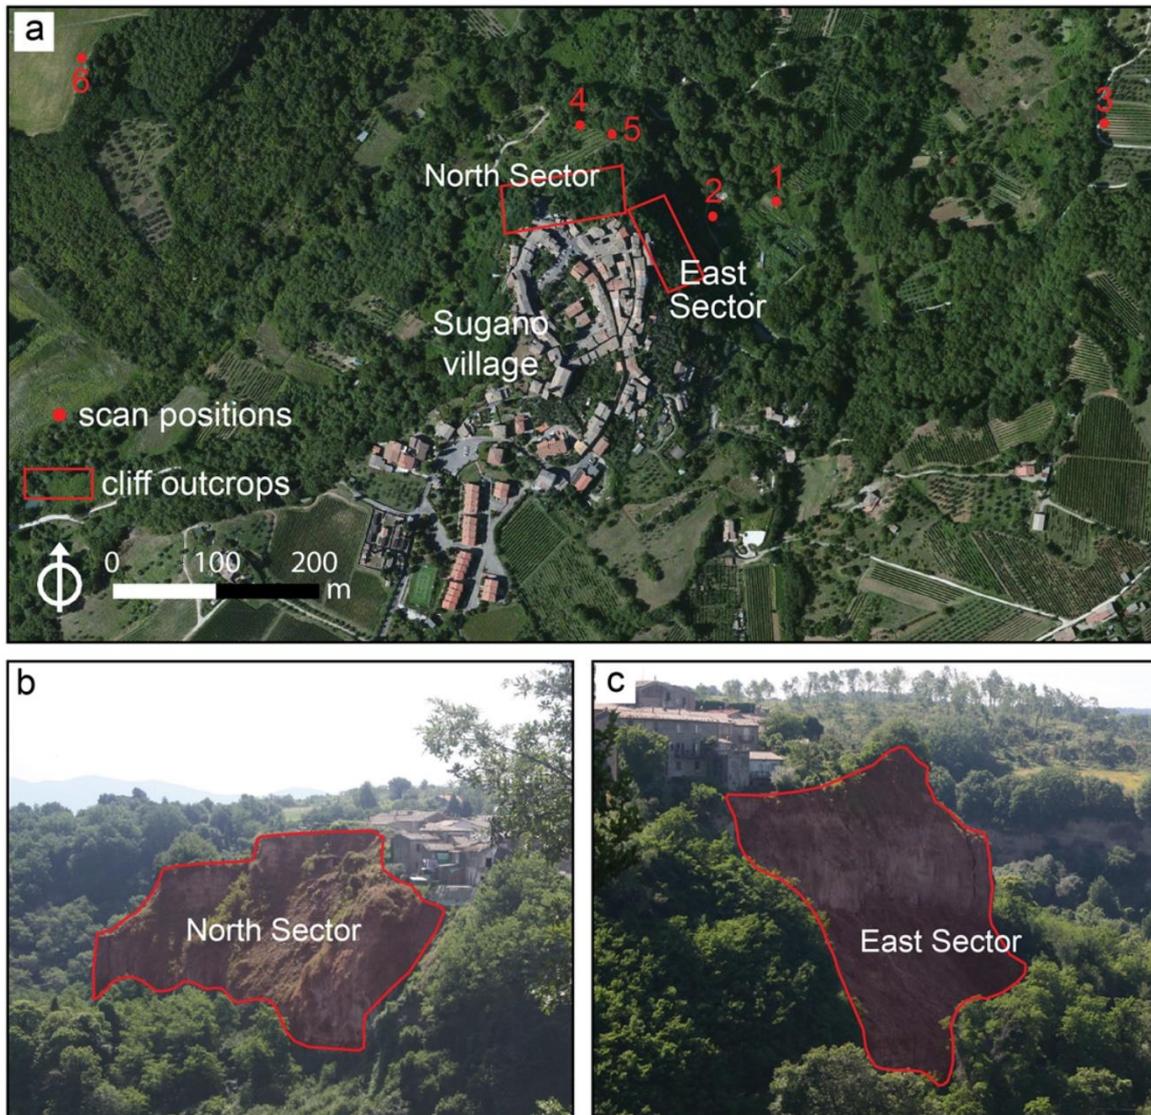
Figure 3. Satellite image (a) and pictures of the north (b) and east (c) sectors of the Sugano cliff. The location of the six scan positions is also reported. Image in (a) is extracted from Google Earth Pro® Version 7.3.2. (2018). Retrieved from <https://www.google.com/earth/download/gep/agree.html>

The geological setting of the Sugano hill resulted from neotectonic and volcanic events occurred during Quaternary. The substratum of the volcanic Alfina plateau consists of Pliocene marine clays, which were deposited during an extensional tectonic phase started in Lower Pleistocene. The normal faults (striking approximately NW-SE) that developed in this phase, formed horst and graben basins which hosted lava and pyroclastic deposits coming from the Vulsini Volcanic Complex [19] which corresponds to the current Bolsena Lake [20]. From a geomorphological point of view, the erosion due to the Paglia River played a key role. In fact, the Plio-Pleistocene marine clays, which represent the substratum of the stratigraphic sequence, can be easily eroded then yielding the typical morphology of the area, characterized by sub-vertical cliffs of volcanic rocks, on which many small towns since the Middle Ages have been built (including Orvieto and Sugano). The lateral spreading phenomena, with consequent rock toppling, affect the volcanic cliffs since ancient times, threatening the stability of the above settlements [5,8]. The height of the Sugano cliff ranges between about 40 and 55 m, and the slope is characterized by two sectors with orientation of about 10° and 100° respectively. In the following sections, these two sectors have been indicated as North and East (Figure 3) and analyzed separately.

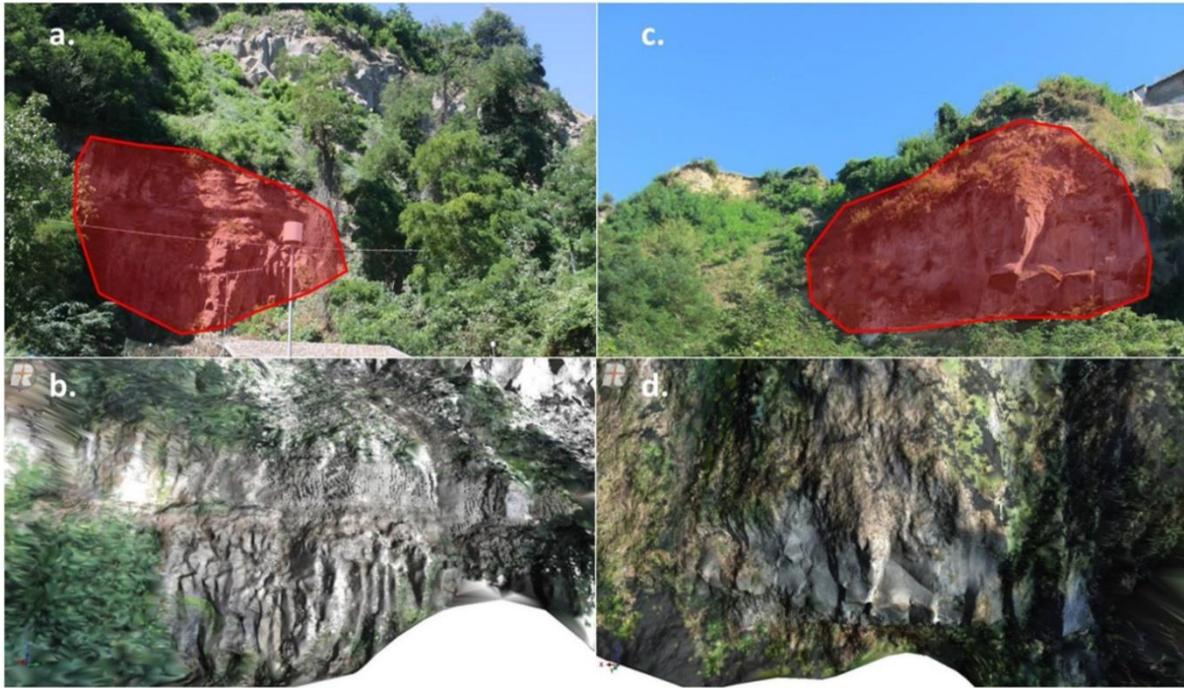
Figure 4. Area of the east (a) and north (c) sectors of the Sugano cliff surveyed with the TLS; (b,d) the corresponding mesh in real color.

After this filtering procedure, a mesh was created by a 2D-Delaunay triangulation algorithm [23,24]. Additional automatic and semi-automatic filters were also applied in order to remove outliers due to artifacts. The achieved result is a 3D solid model of the Sugano cliff with cell resolution ranging from 0.003 m² to 0.6 m² (Figure 4). Although part of the cliff was not surveyed due to the presence of thick vegetation, about 13,500 m² of the rock surface have been investigated through the laser scanner survey.

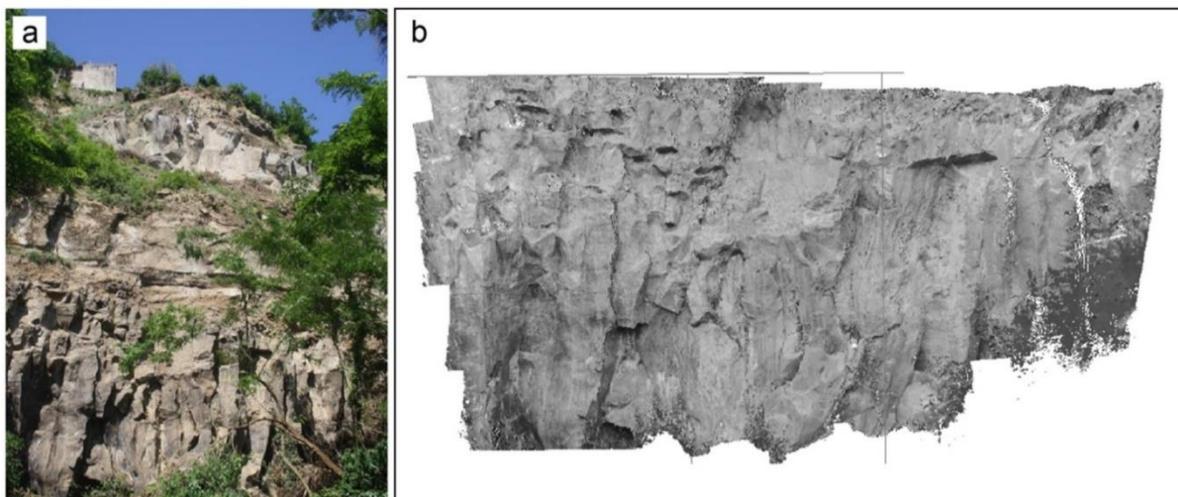
Figure 5. (a) The lower part of the east sector (EL) of the Sugano cliff; (b) The corresponding point cloud resulting from the TLS.

The geomechanical characterization of the Sugano cliff has been carried out by analyzing the collected point clouds with Split-FX software (Split Engineering, Tucson, Arizona, USA) [25], using both manual and automatic approaches. The aim of the analysis was to achieve information about the rock mass joint sets. In this respect, the lower part of the East sector (EL, see Figure 5) has been also analyzed through an in situ geomechanical survey, which shows the presence of two sub-vertical joint sets that shall release prismatic blocks (Figure 6). The in-situ geomechanical survey was performed in order to obtain a reliable calibration measurement (through a conventional approach) to be compared with results from TLS analysis for validation purposes. The same analysis was not performed on the other sectors of the cliff (i.e., the upper east (EU) and the north (N) sector) due to the poor safety conditions.

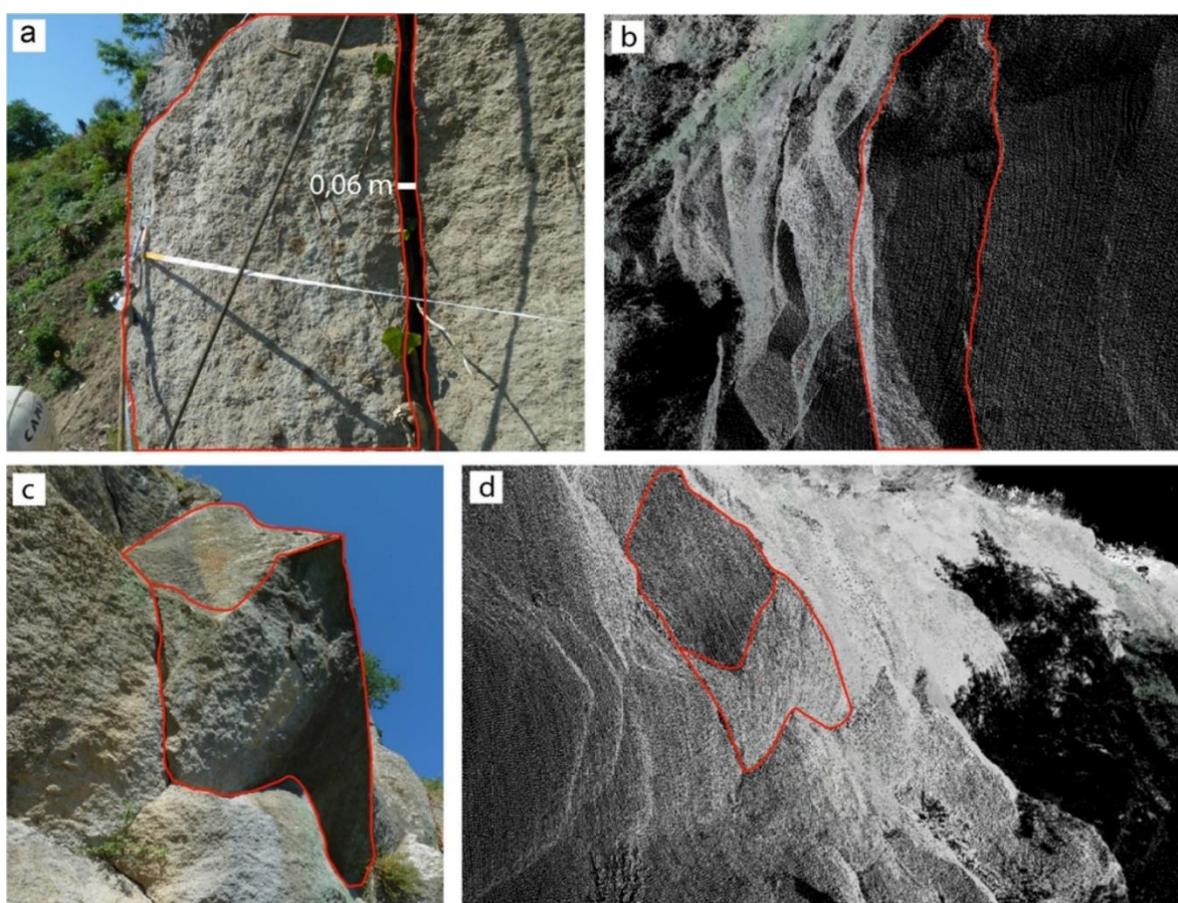
Figure 6. (a,c) Prismatic blocks prone to the detachment observed during the in situ geomechanical survey; and (b,d) the same blocks identified on the point cloud.

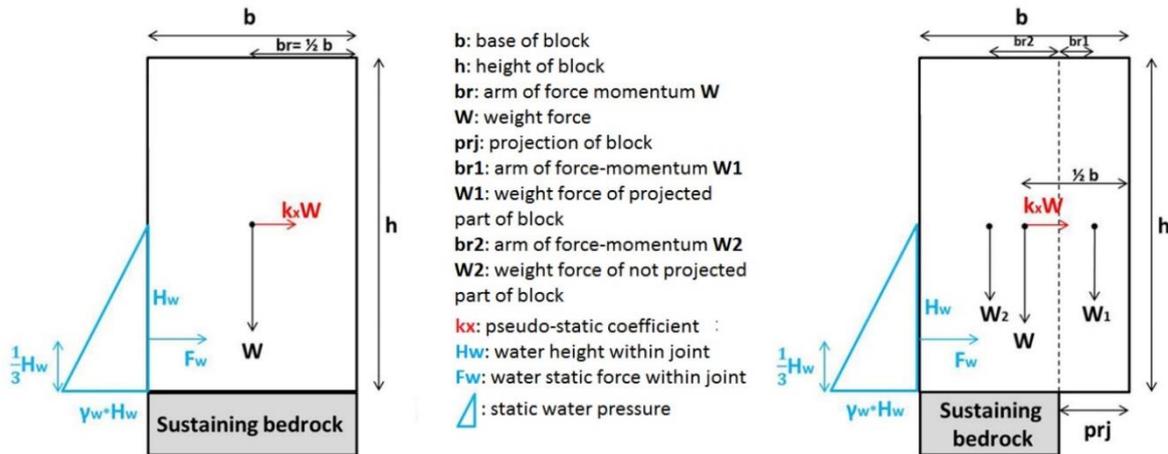
Figure 7. Two-dimensional scheme of not projecting (left) and projecting block (right) subjected to weight force, seismic pseudo-static force and water static force within the joint.

Beyond the different destabilizing actions, two types of analysis have been performed for the Sugano cliff, namely considering the presence of projecting and not projecting blocks (Figure 7).

In the absence of projection (i.e., if the sustaining bedrock is as large as the potentially-unstable block) and considering the base as horizontal, the block is in equilibrium with respect to the toppling failure conditions. In case of projection, two weight forces have to be considered, i.e., W_1 for the projecting part of the block and W_2 for the not projecting part. In order to keep the equilibrium state, this condition has to be verified:

$$W_2 b_{r2} > W_1 b_{r1} \tag{1}$$

where br is the moment arm of W (1 and 2 subscripts indicate the projecting and not projecting portion of block, respectively). In this sense, if:

$$prj > \frac{b}{2} \tag{2}$$

then the block is subject to rock topple (b is the base length of block). In this study, projection prj average value of 0.44 m varying in a range between ± 0.22 , according to field observations on the outcropping blocks. At this point, for values of prj lower than $b/2$, a sensitivity analysis was performed.

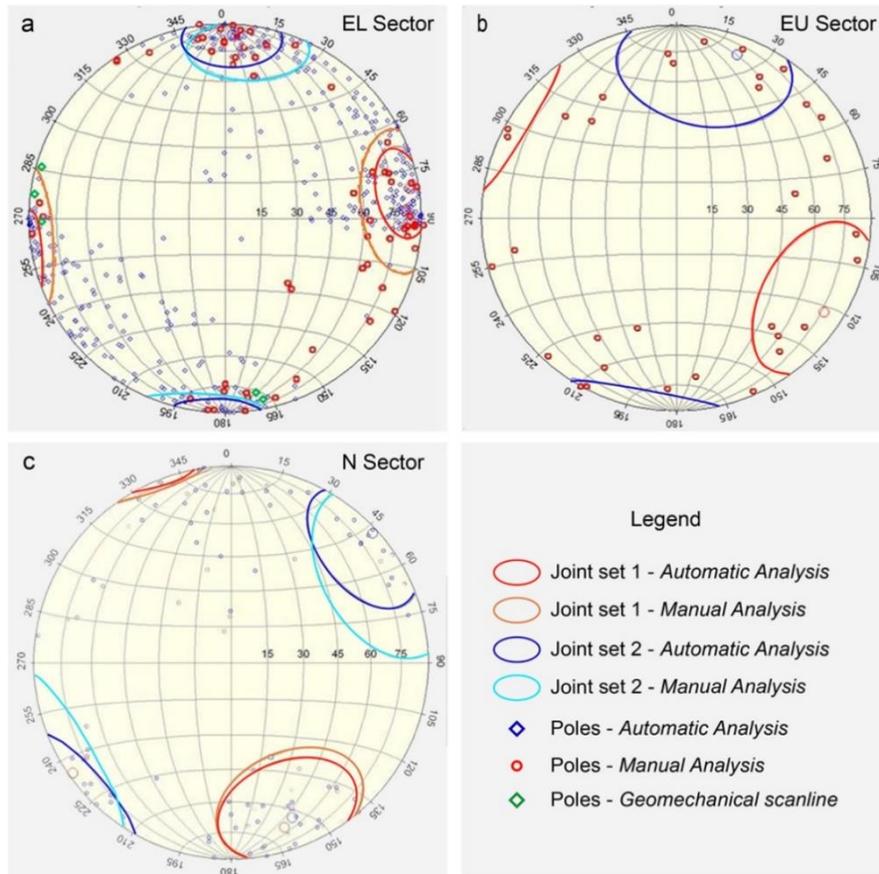
Figure 8. Final stereo-plot derived from the analysis of the TLS point cloud and geomechanical scanline for EL (a), EU (Upper East) (b), and N (North) (c) outcrop.

According to the results of the geomechanical analysis (Figure 8 and Table 3), two main joint sets were identified for all the analyzed outcrops by Split-FX. In particular, the joint sets identified in the two outcrops of the east sector (i.e., EL and EU), are almost concordant and show high dip angles, isolating blocks of columnar shape. On the contrary, the dip direction values of the joint sets identified in the northern sector of the cliff are rather different than those in the east sector, although characterized, in turn, by high dip angles. Specifically, one of the two systems is sub-parallel to the direction of the slope, acting, therefore, as the main surfaces of detachment of blocks. All joint sets, identified in the investigated sectors of the Sugano cliff, are characterized by high values of persistence (i.e., average values ranging between 70% and 80%), expressed in the present paper as the percentage length of the joint with respect to the whole outcrop. Excluding a few tightened joints or joints characterized by opening values less than 1 cm, the analysis highlighted the widespread

presence of joints with opening values ranging approximately between 3 and 7 cm. An exception is represented by a release area of the rock mass (located at the intersection of the East and North sectors of the cliff), where the opening value reaches 75 cm (Figure 9). Joints are often filled with debris in a fine matrix, resulting from rock cracking and subsequent weathering.

On the basis of the obtained results, we can assert that the investigated outcrops are characterized by the presence of large blocks, in particular for upper east and north sector. The geometry of these blocks has therefore been considered for a preliminary analysis of the slope stability conditions of the cliff, including a sensitivity analysis aimed at evaluating potential triggering scenarios.

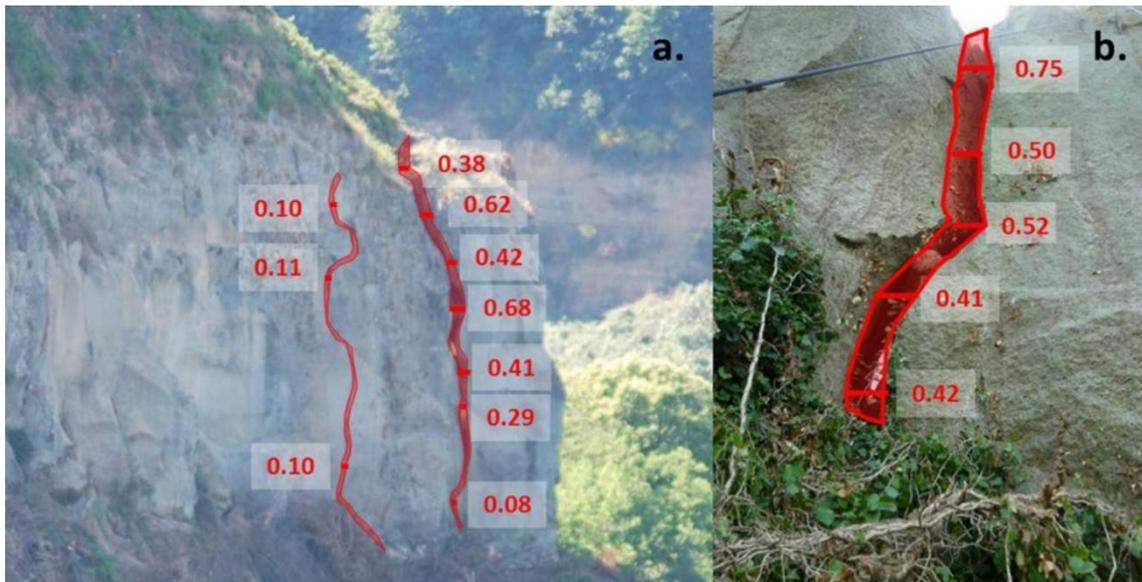
Figure 9. Opening values of fractures measured in a released area of the cliff at the intersection of the east (a) and north (b) sectors of the cliff.

According to the geomechanical analysis and the morphological evidences, several potentially unstable rock blocks were identified and their volume was calculated using the RiSCAN PRO software (Figure 10). In this respect, it is worth noting that the block having the largest volume (i.e., block “I”, approximately 210 m³) is the same block characterized by the higher opening values of the joints (Figure 9).

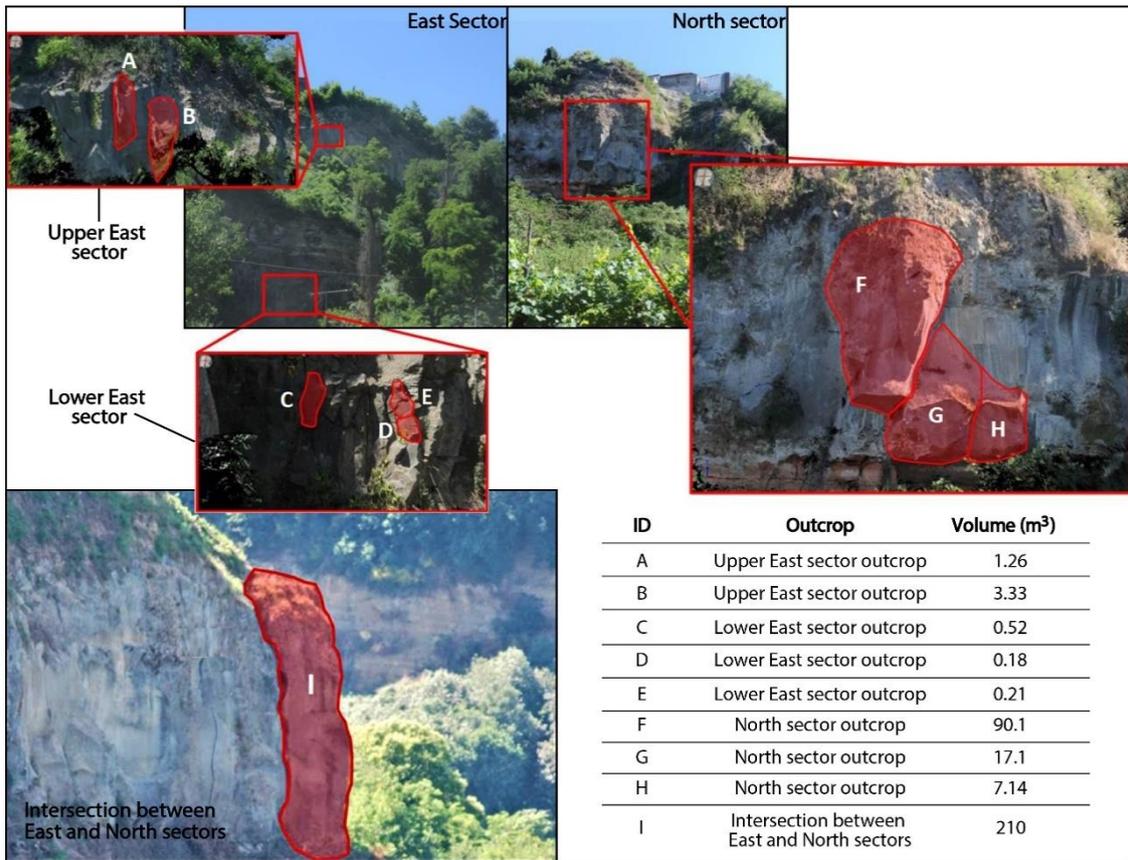
Figure 10. Rock blocks prone to failure on the Sugano cliff. The table reports the computed volumes of each rock block represented in the pictures.

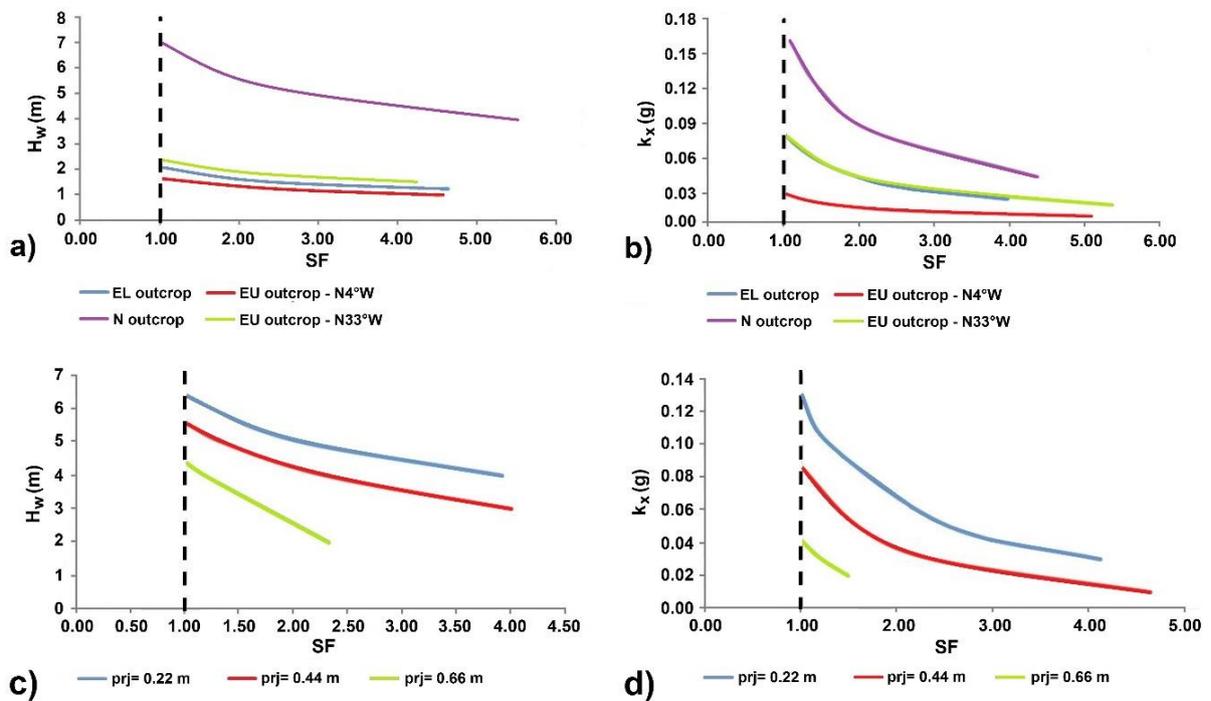
Figure 11. SF vs. H_w (a) and k_x (b) from a sensitivity analysis performed for the considered sectors of the slope. SF vs. H_w (c) and k_x (d) from a sensitivity analysis performed, in the case of projection, for the north sector of the slope.

With regard to the slope stability analysis performed by varying the triggering pseudostatic actions (i.e., seismic force and hydrostatic pressures within the joints), it results that:

1. in the absence of projection, the east sector of the cliff reaches unstable conditions for rock toppling when water height H_w in the joints ranges between 1.6 and 2.5 m (Figure 11a) or when the values of pseudostatic coefficient k_x range between 0.03 and 0.08 (Figure 11b). Since, in this sector, no projected blocks were identified, no triggering scenarios were supposed for such conditions; and

2. in the absence of projection, the north sector of the cliff reaches unstable conditions for rock toppling when the water height H_w in the joints ranges between 7 and 7.4 m (Figure 11a) or when the values of the pseudostatic coefficient k_x exceeds 0.17 (Figure 11b). In the case of projections, the north sector reaches unstable conditions for rock toppling when the water height H_w in the joints ranges between 4 and 6.5 m (Figure 11c) or when the values of pseudostatic coefficient k_x ranges between 0.04 and 0.14 (Figure 11d), depending on the entity of projection.

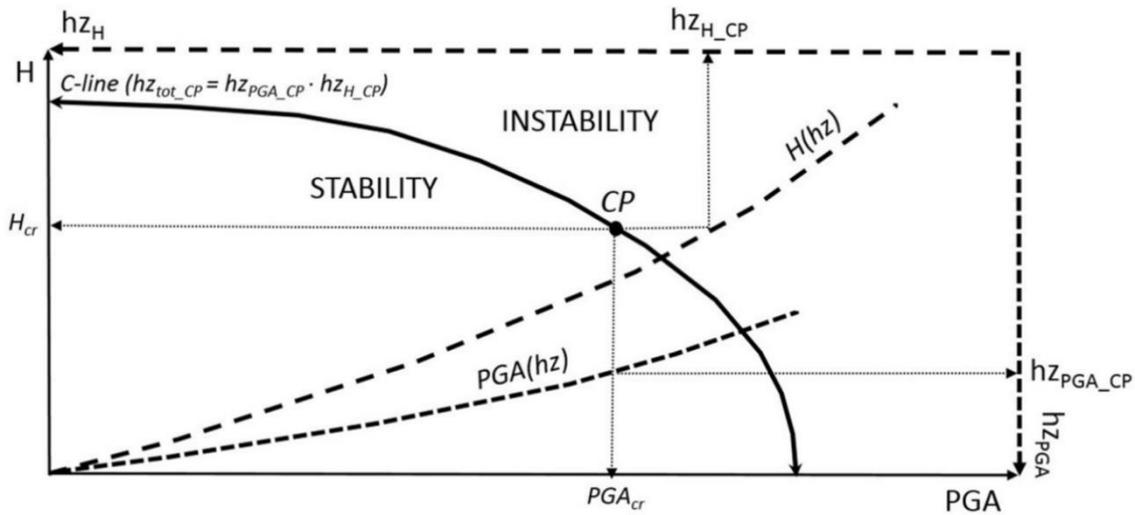
Figure 12. Conceptual stability chart.

To investigate the stability conditions of the Sugano cliff taking into account the effect induced by earthquakes and/or by the presence of water within the joints, a conceptual stability chart has been designed (Figure 12). This chart conceptualizes a hazard approach in a conventional sensitivity analysis output, and thus it can be applied to different case studies. The chart highlights the possibility that a slope could fail if two events occur, each having a different and independent probability of occurrence. Specifically, a critical line (*C-line*) distinguishes two fields related, respectively, to stability and instability conditions. Each point of this line (critical point, *CP*) corresponds to a couple of values representing the critical water height saturating the joints (H_{cr}) and the critical peak ground acceleration (PGA_{cr}). Each critical value is associated with a specific hazard (H_z , which represents the probability of occurrence); consequently, the total hazard of the *CP* ($H_{z_{tot_CP}}$) can be computed by combining the two probabilities of occurrence:

$$H_{z_{tot_CP}} = H_{z_{PGA_CP}} * H_{z_{H_CP}} \quad (9)$$

On the basis of this conceptual scheme, the *C-line* is a not-uniform hazard upper-bound-curve which shows how the highest hazard conditions can be reached in correspondence of both the highest admissible H value and the maximum expected PGA. At the same time, the critical line allows to

deduce that the highest hazard is concentrated at the middle track of the line while it decreases moving toward the endmembers.

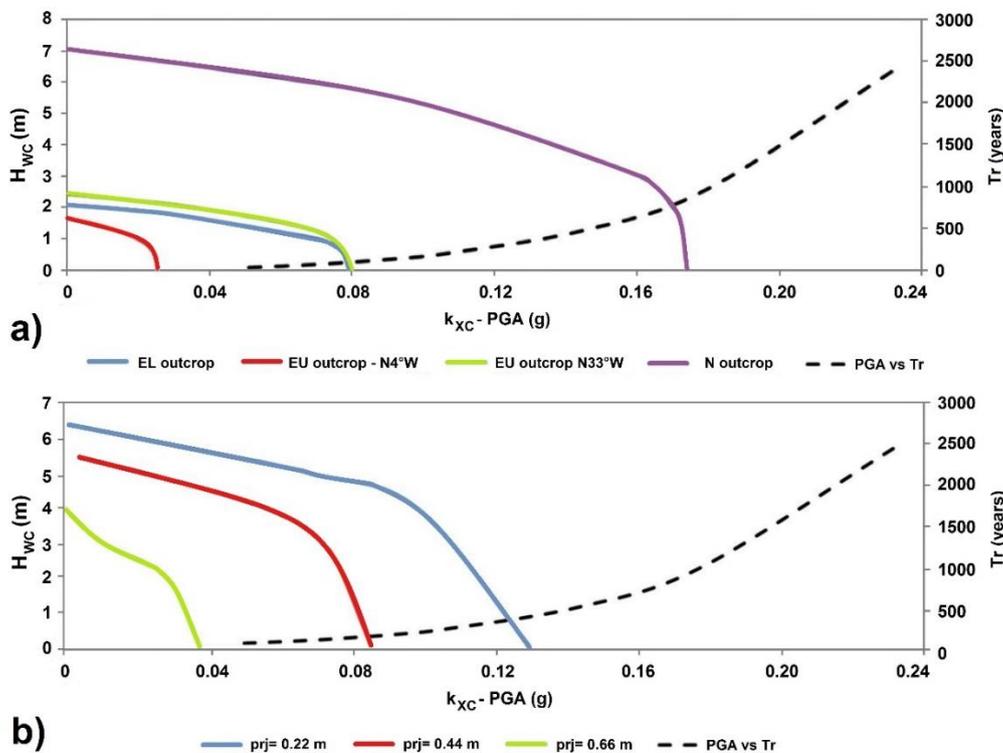
Figure 13. Stability chart, in absence of projection on EL, EU and N sectors (a), and in case of projection on the N sector (b).

Since the hazard related to the water height saturating the joints is not available for the Sugano case study, the stability charts were obtained by considering the h_{ZPGA} only. In particular, the relationship between k_x and the corresponding return period T_r (specific values for the Sugano cliff can be found at <http://esse1-gis.mi.ingv.it/>) was used for quantifying such a hazard.

As it results from the derived stability charts, in the case of Sugano the overall stability of the east sector is lower than the north one (Figure 13a). Furthermore, the northern sector results as more stable also considering projection of the blocks (Figure 13b).
