# Rock fall instabilities and safety of visitors in the historic rock cut monastery of Vardzia (Georgia)

**ABSTRACT:** This paper reports the main results of a project developed in cooperation with National Agency for Cultural Heritage Preservation of Georgia, and aimed at envisaging the stability conditions of the Vardzia Monastery slope (rupestrian rock cut city cave in the south-western Georgia). The site has always been affected by instability processes along the entire slope, including small block falls from the upper breccia layer and large collapses from the middle layer. The study involves: rock mechanics characterization, geo-engineering survey, geo-structural and kinematic analysis, rockfalls modelling, geomatic acquisitions and elaboration. The geomechanical characteristics of volcanoclastic and pyroclastic rocks were determined by means of geomechanical field surveys, rock mass classification through scan lines techniques, and laboratory tests on rock blocks and cores. In order to carry out a semi-automatic detection of discontinuities and to implement mitigation activities, a 3D Terrestrial Laser Scanning survey has been carried out. Potential rockfalls have been simu

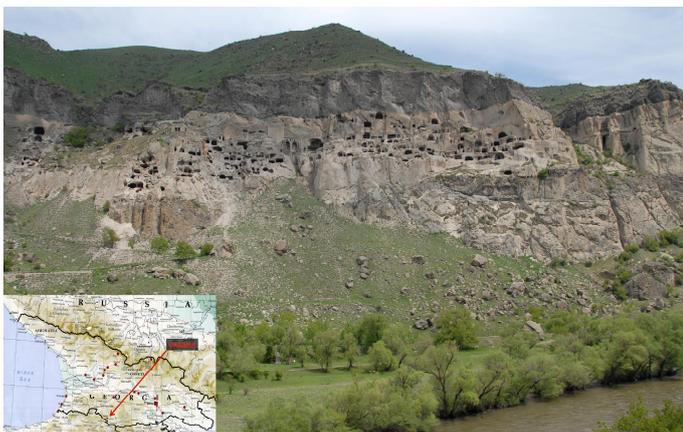
The caves stretch along the cliff for some 800 m and up to 50 m within the rocky wall (Figure 1).

Figure. 1 The rock-cut city of Vardzia (Georgia).

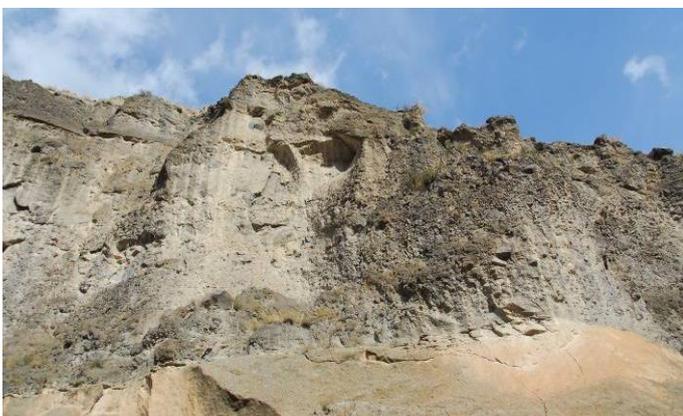
a) Rock falls, topples or wedge failure often due to the lack of support of the underlying layer affected by planar sliding (Figure 3);

Figure 3. Rock falls in the upper part of the layer 1.

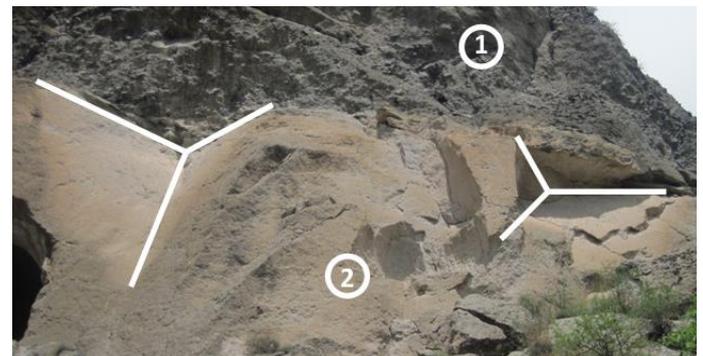
a) wedge failure and rock fall (figure 5);

Figure 5. Wedge failure at the contact between layer 1 (on top) and layer 2.

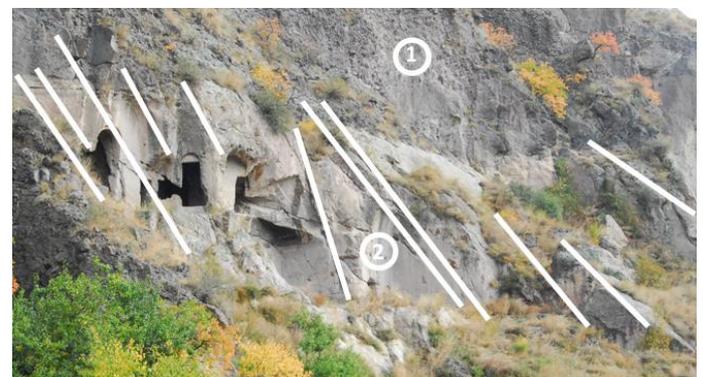
b) high and low angle planar rock slide along the mains structural setting (Figure 6).

Figure 6. High and low angle planar rock slide.

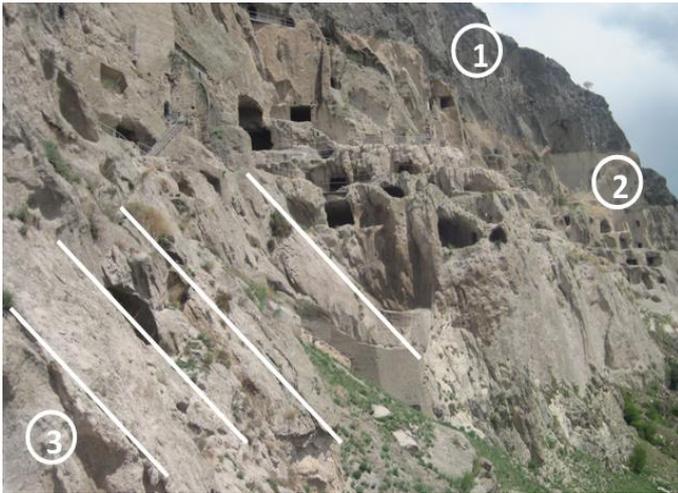
a) planar sliding along the mains structural setting (Figure 7);

Figure 7. Planar sliding along the mains structural setting
